# Manhole Inspection Summary

Manhole # S25A\_\_025MH

Insp Date: **4/6/09 8:40 AM**

**Location** Address: **1039 EDMONDSON-BENNET** Cross Street: **ARLINGTON AVE**

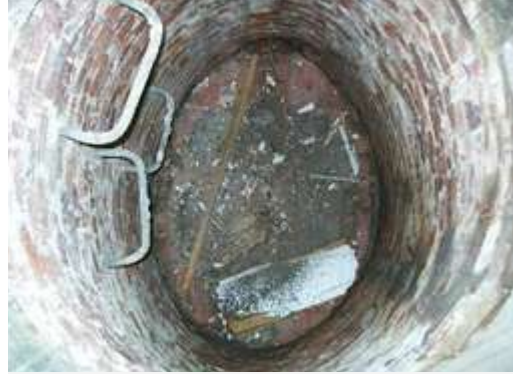
Top View

DEBRIS ON CHANNEL, STAINING ON THE WALL SHOWS EVIDENCE OF INFILTRATION IN CORBEL AND

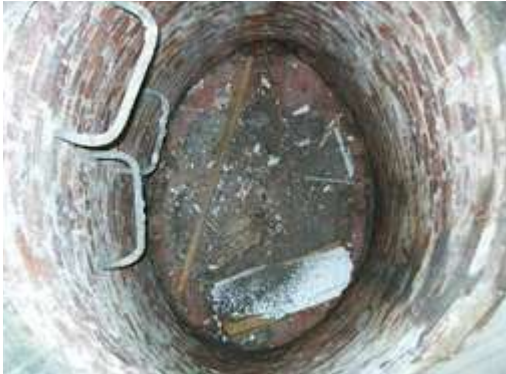
Defect 2

infiltratuib and intrusion on corbel and infiltration on barrel

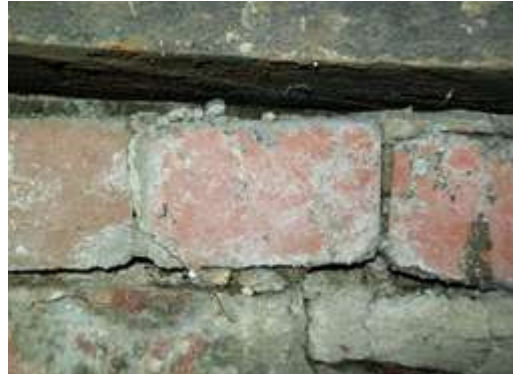
Defect 1

deteriorated BETWEEN FRAME AND CORBEL WALL.

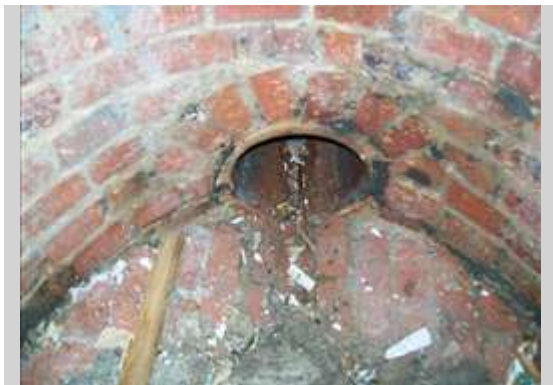
12 O'Clock Outflow

8 in. Circular Gravity Sewer  
Pipe Out @ 12 O'Clock

Infiltration: **None** Pipe Seal Cond: **Sound**
